S/1731/2019
1 March 2019
Original: ENGLISH

NOTE BY THE TECHNICAL SECRETARIAT

**REPORT OF THE FACT-FINDING MISSION REGARDING THE INCIDENT
OF ALLEGED USE OF TOXIC CHEMICALS AS A WEAPON
IN DOUMA, SYRIAN ARAB REPUBLIC, ON 7 APRIL 2018**

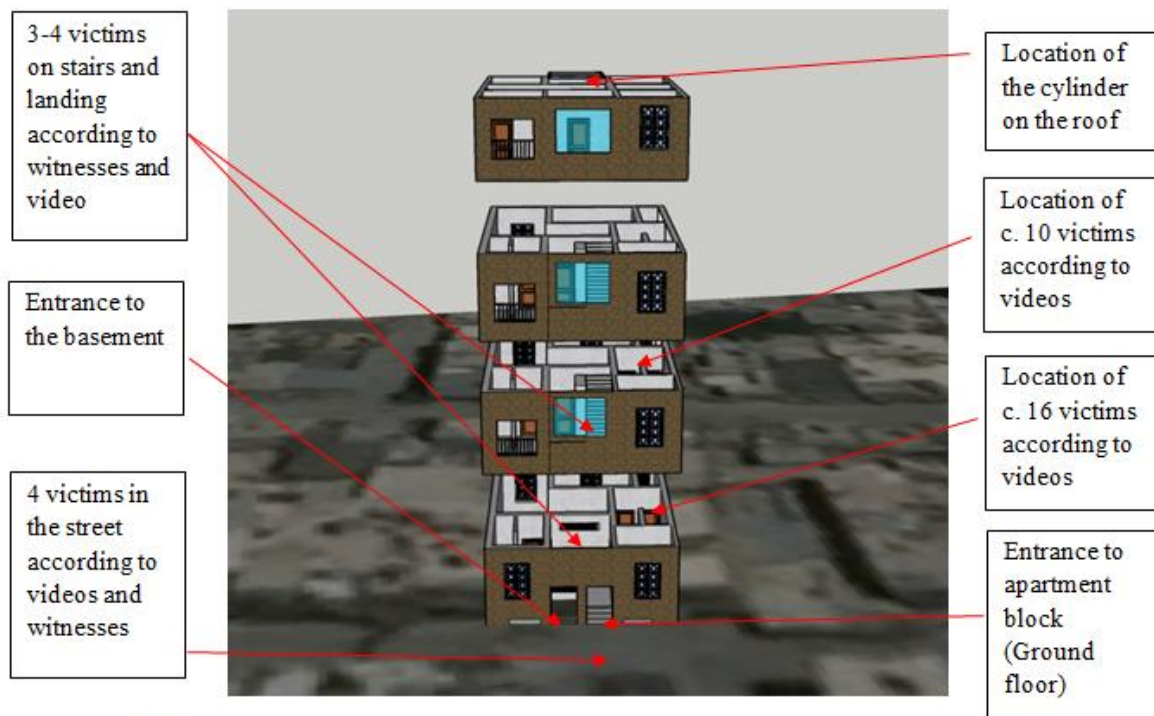
FIGURE 6: 3D LAYOUT OF LOCATION 2 WITH DISTRIBUTION OF ROOMS AND REPORTED LOCATIONS OF ALLEGED VICTIMS

- 8.26 The cylinder was located on the floor of the roof terrace, on the third floor, on the east side of the building, with its nozzle poised over a circular opening in the concrete. The roof terrace where the cylinder was observed corresponds to the ceiling of a room in an apartment on the second floor.
- 8.27 The following three dimensional layouts of the apartment block depict the spatial relationship between the alleged point of impact of the cylinder and the rooms where fallen victims of the alleged chemical attack were located according to the videos provided by witnesses and their accounts.

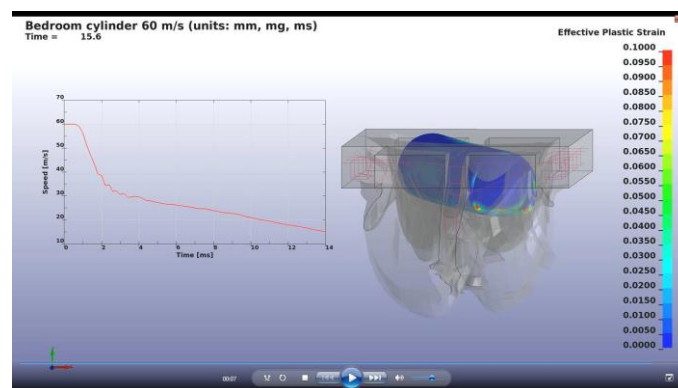
FIGURE 10: COMPUTER MODULATION OF THE APERTURE AND CYLINDER IMPACT

- 8.31 The analyses indicated that the structural damage to the rebar-reinforced concrete terrace at Location 2 was caused by an impacting object with a geometrically symmetric shape and sufficient kinetic energy to cause the observed damage. The analyses indicate that the damage observed on the cylinder found on the roof terrace, the aperture, the balcony, the surrounding rooms, and the rooms underneath and the structure above, is consistent with the creation of the aperture observed in the terrace by the cylinder found in that location.

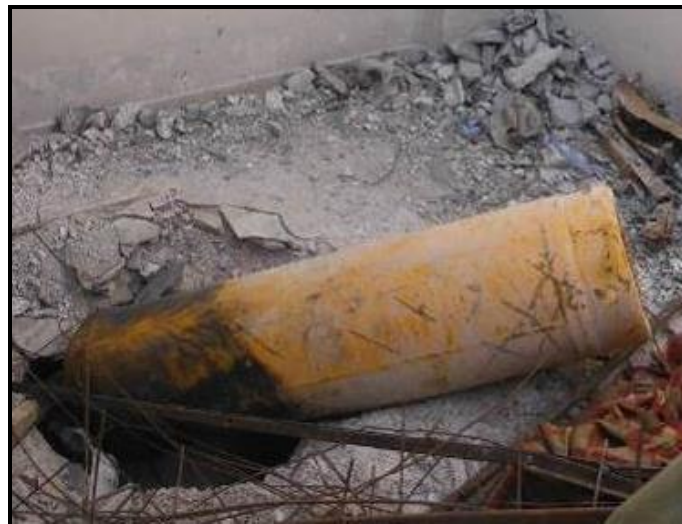
3. The aperture observed was circular in shape with approximately 45 degrees angular edges.
4. The mangled ironwork present on the patio indicated that there would have been a metallic frame and mesh covering it at one stage, though it was not clear whether this would have been present at the time of the alleged incident or had been demolished prior to that. The visual damage on the body of the cylinder indicates that the lateral aspect of the cylinder did not slide on the mesh but it hit perpendicularly.

FIGURE A.6.2 CYLINDER WITH VISIBLE DAMAGE LIKELY ORIGINATING FROM THE MESH

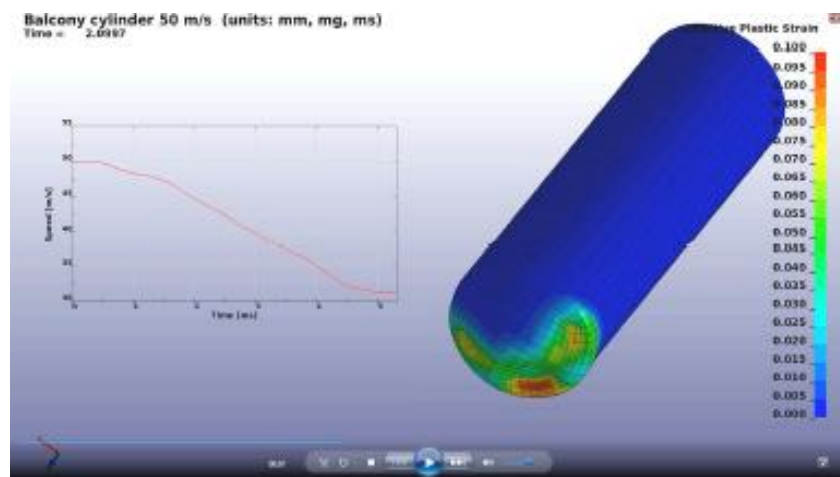
FIGURE A.6.6 CYLINDER FRONT END DEFORMATION IF IMPACTED WITH THE CORNER ON THE ROOF ABOVE THE BALCONY²¹

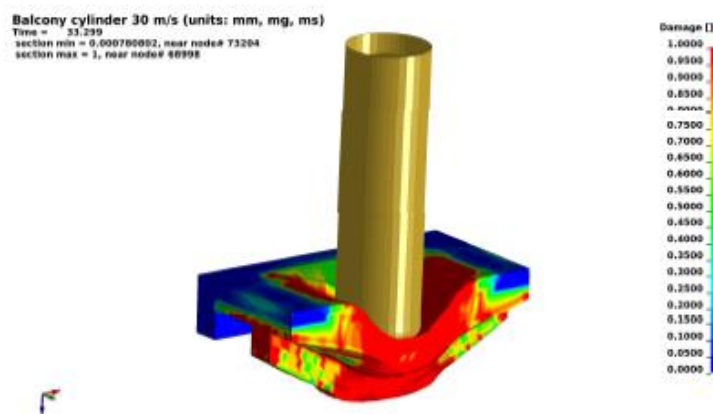
FIGURE A.6.7(b) DAMAGE ON THE CEILING IN THE CASE OF LOW SPEED IMPACT
