S/1731/2019
1 March 2019
Original: ENGLISH

NOTE BY THE TECHNICAL SECRETARIAT

**REPORT OF THE FACT-FINDING MISSION REGARDING THE INCIDENT
OF ALLEGED USE OF TOXIC CHEMICALS AS A WEAPON
IN DOUMA, SYRIAN ARAB REPUBLIC, ON 7 APRIL 2018**

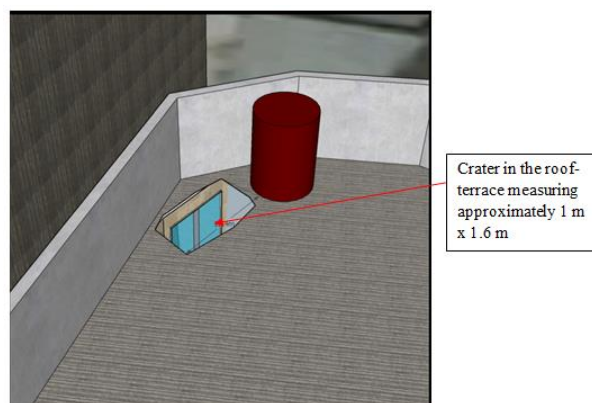
FIGURE 7: COMPUTER-GENERATED VIEW OF THE APERTURE ON THE ROOF TERRACE

- 8.31 The analyses indicated that the structural damage to the rebar-reinforced concrete terrace at Location 2 was caused by an impacting object with a geometrically symmetric shape and sufficient kinetic energy to cause the observed damage. The analyses indicate that the damage observed on the cylinder found on the roof terrace, the aperture, the balcony, the surrounding rooms, and the rooms underneath and the structure above, is consistent with the creation of the aperture observed in the terrace by the cylinder found in that location.

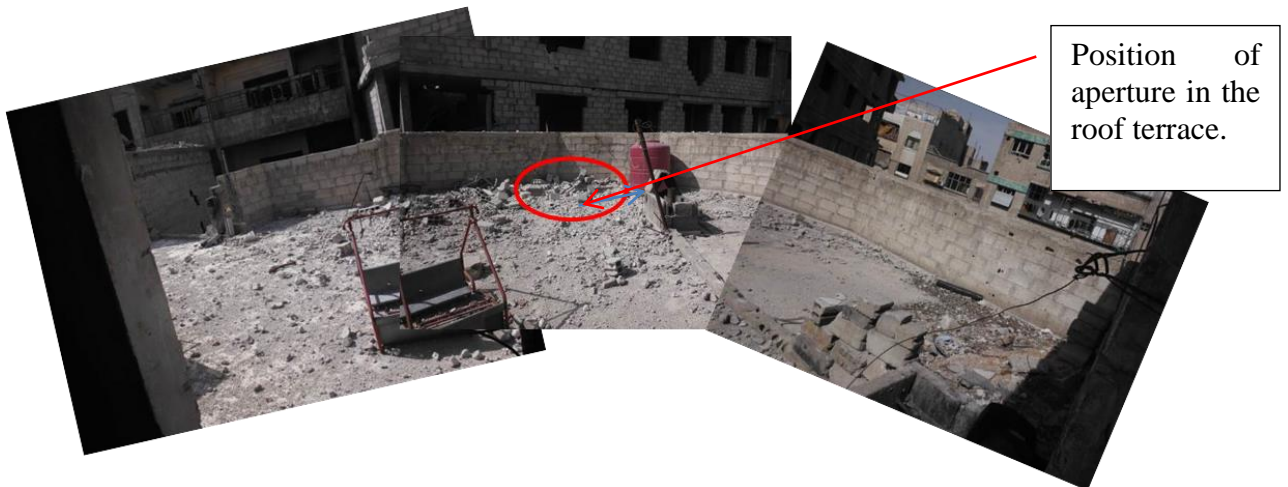
FIGURE A.7.3 ROOF OF LOCATION 4

Area shaded in red marks the roof of Location 4

The aperture was located close to a surrounding wall and next to the water tank with approximate dimensions of 166 x 105 cm. The distance from the adjacent building varies between 230 cm and 250 cm.
